A HYDROGEOLOGICAL INVESTIGATION OF THE CLOSED NORWICH WASTE DISPOSAL AREA IN NORWICH, ONTARIO

FEBRUARY 1990

(No. 070701)

Report prepared by:
R. Blackport
B. Boyle

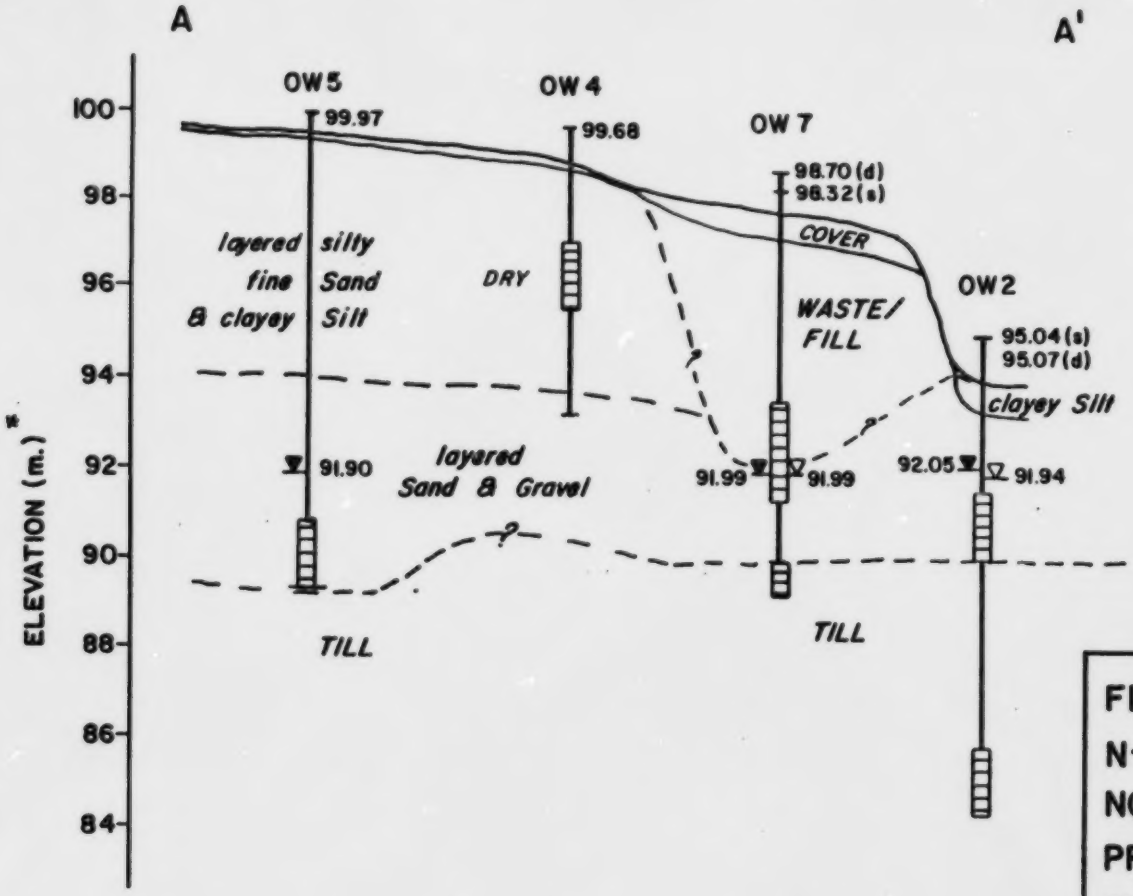
FIGURE 5

Along the northern boundary of the waste disposal area, (i.e. at OW5 and OW4) approximately 5 to 6 metres of interlayed silty fine to very fine sand, silt and clay is present below ground surface (Figure 5). Beneath this unit, which is apparently of deepwater glaciolacustrine origin (Barnett, 1982). An interval of interlayered medium to coarse sand and gravel, having local cobbly and silty lenses, with a thickness of about 3 to 4 metres was enccuntered (Figure 6). This glaciolacustrine shallow water deposit underlies the entire site and was found at each of the drilling locations. At borehole OW3, alluvial deposits comprised mainly of layered silty clay and clayey silt were penetrated above the sand and gravel unit.

A dense, grey stony sandy silt till (Appendix A), presumed to be the Catfish Creek Till, was found beneath the layered sand and gravel at OW1, OW2, OW3, OW5 and OW7 (Figures 5 and 7). The till

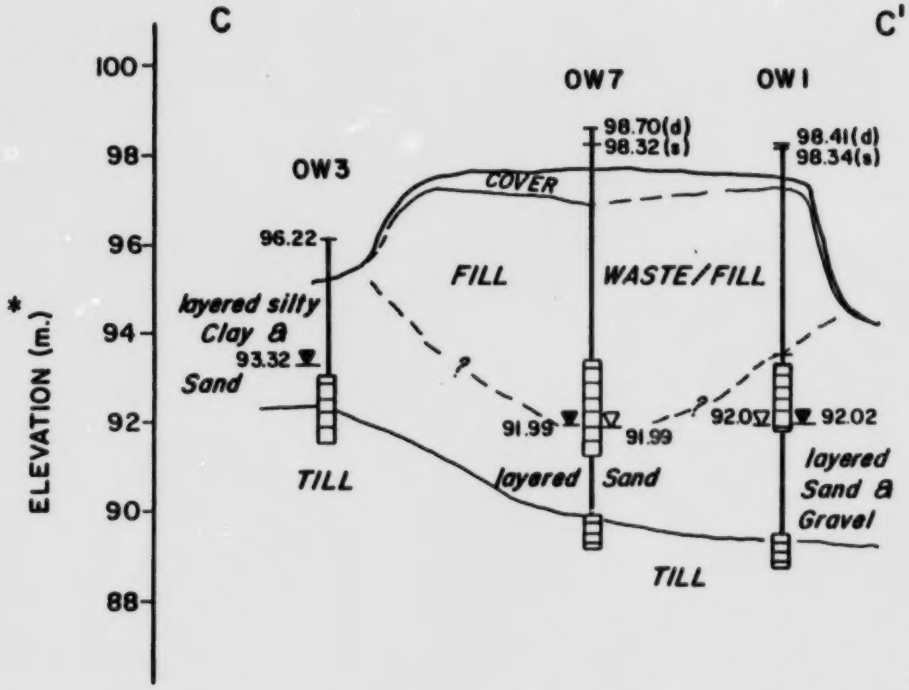
Domestic waste and/or fill was encountered at three of the monitoring locations in this study: OW1, OW6 and OW7. The greatest thickness of waste was found at OW7, where approximately 5 metres were penetrated (Figure 7).

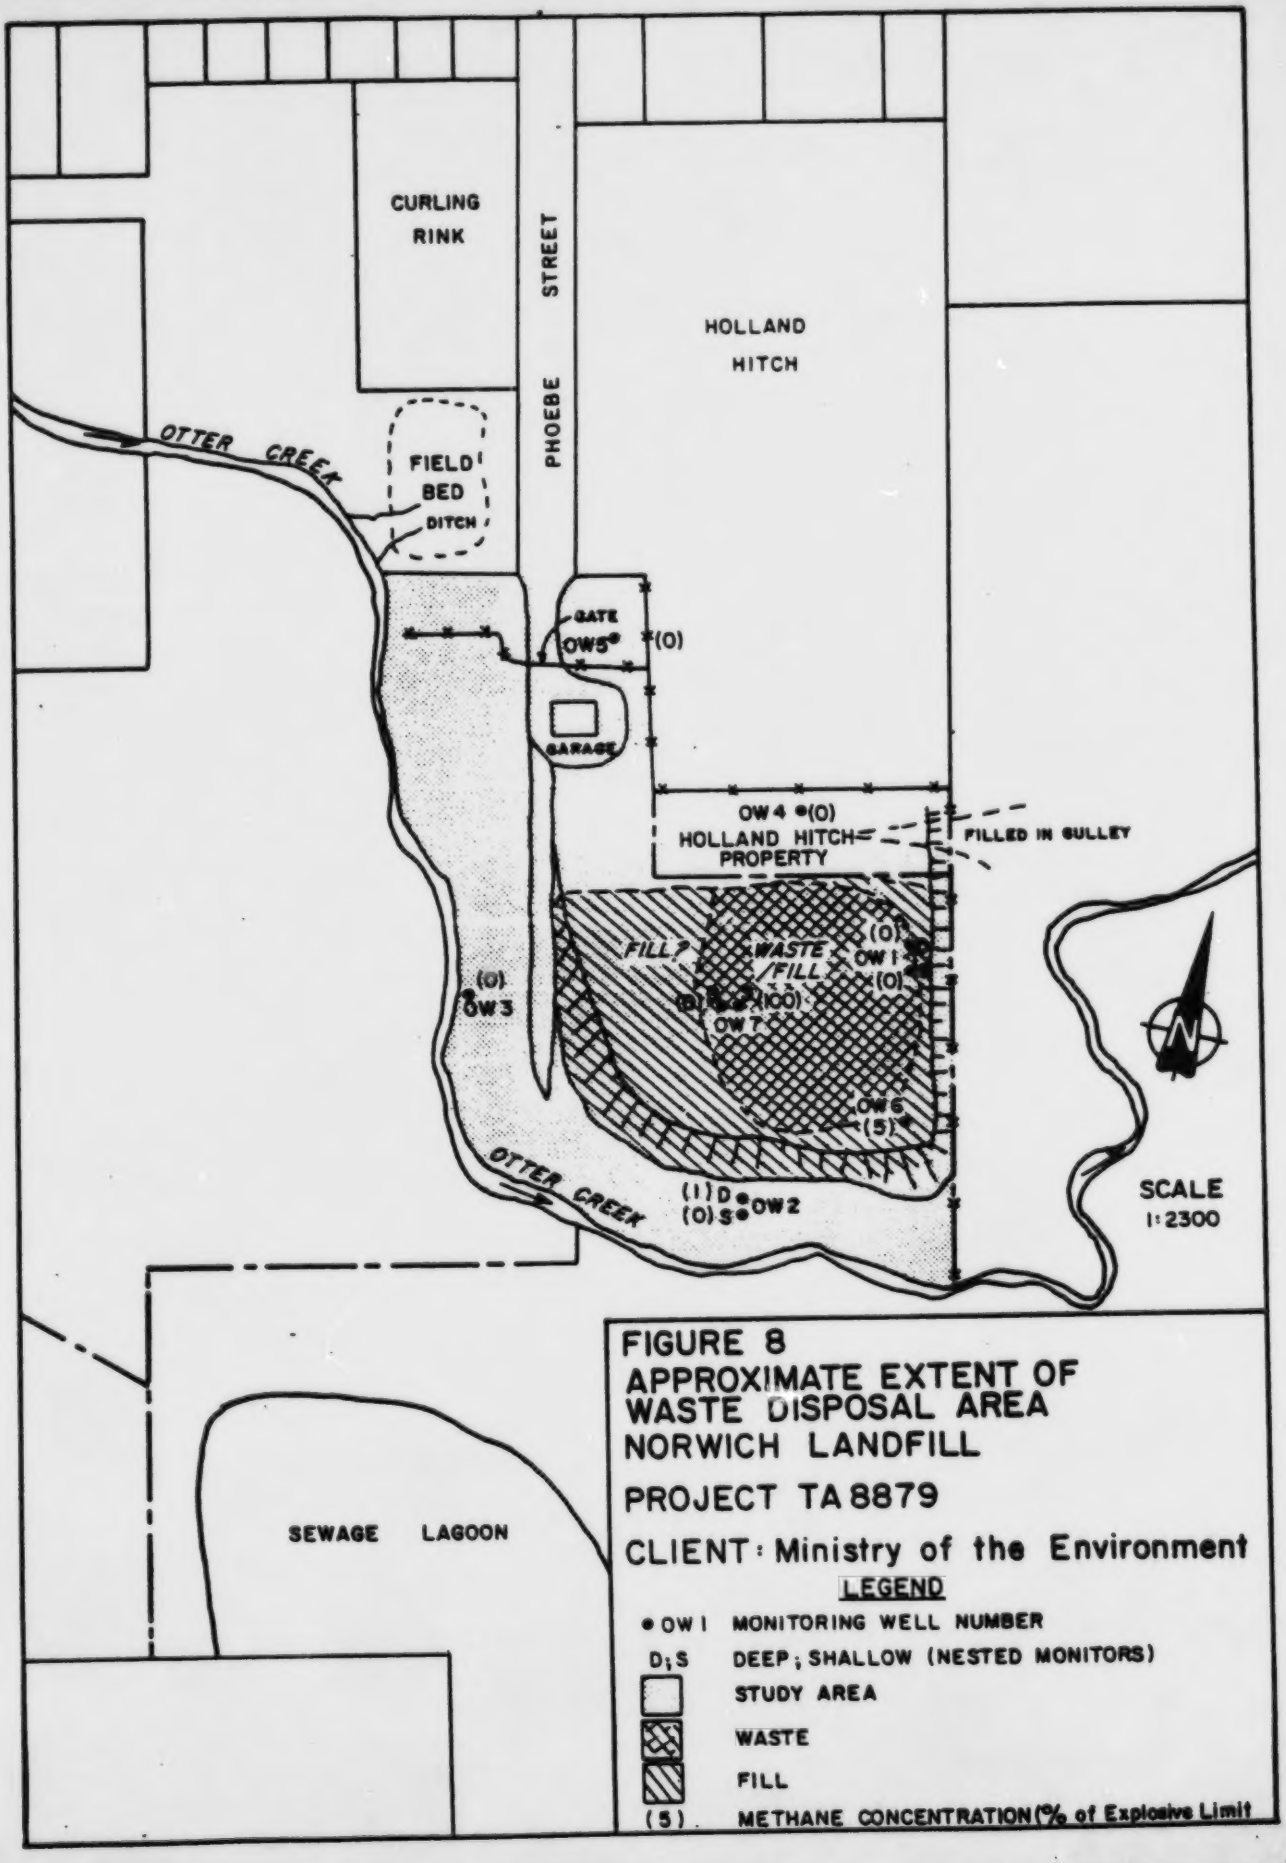
10) A potential landfill gas problem exists in the centre of the landfill (OW7-S) where gas concentrations were found to be in excess of 10% of the lower explosive limit (>.047% methane). Minor concentrations were detected in two other landfill monitoring wells, but there does not appear to be any lateral methane migration. No methane was detectable above ground surface. There are no structures in the immediate area of the landfill which could potentially collect gas, and in the present state of the landfill, there is no methane hazard.

1) There is no immediate gas hazard if the landfill remains in its present state. However, if any future excavation or development of the site were to take place, this situation could change. Open flames or sparks should not be used in the vicinity of OW-7.

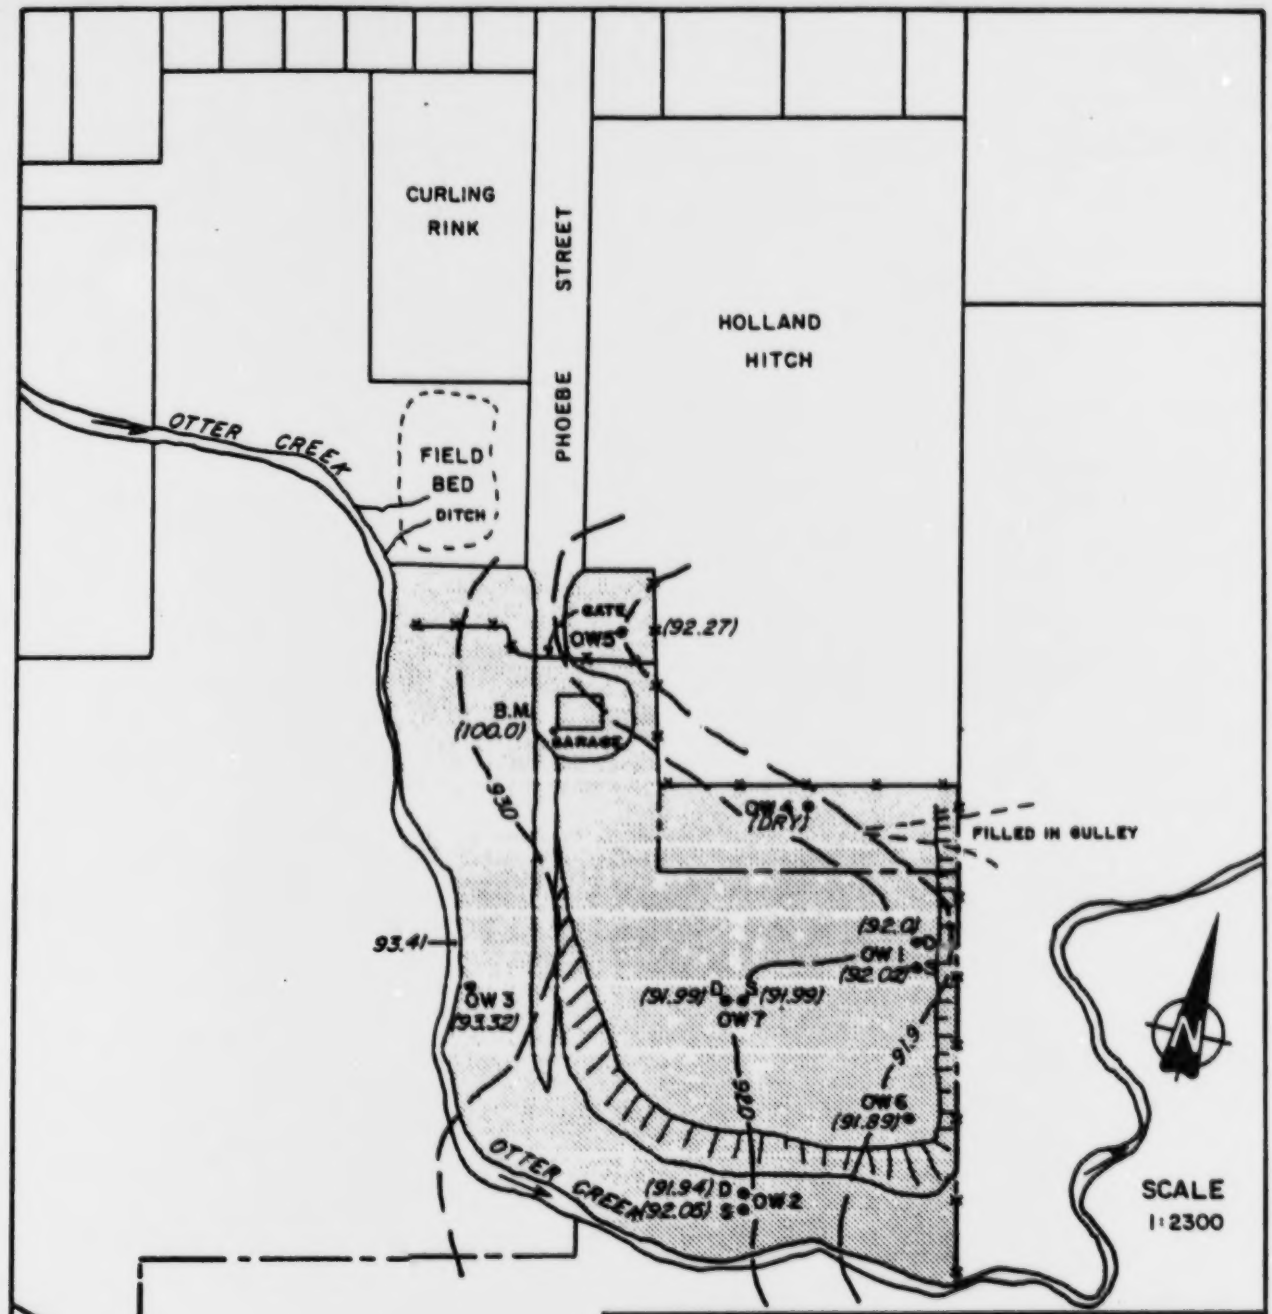
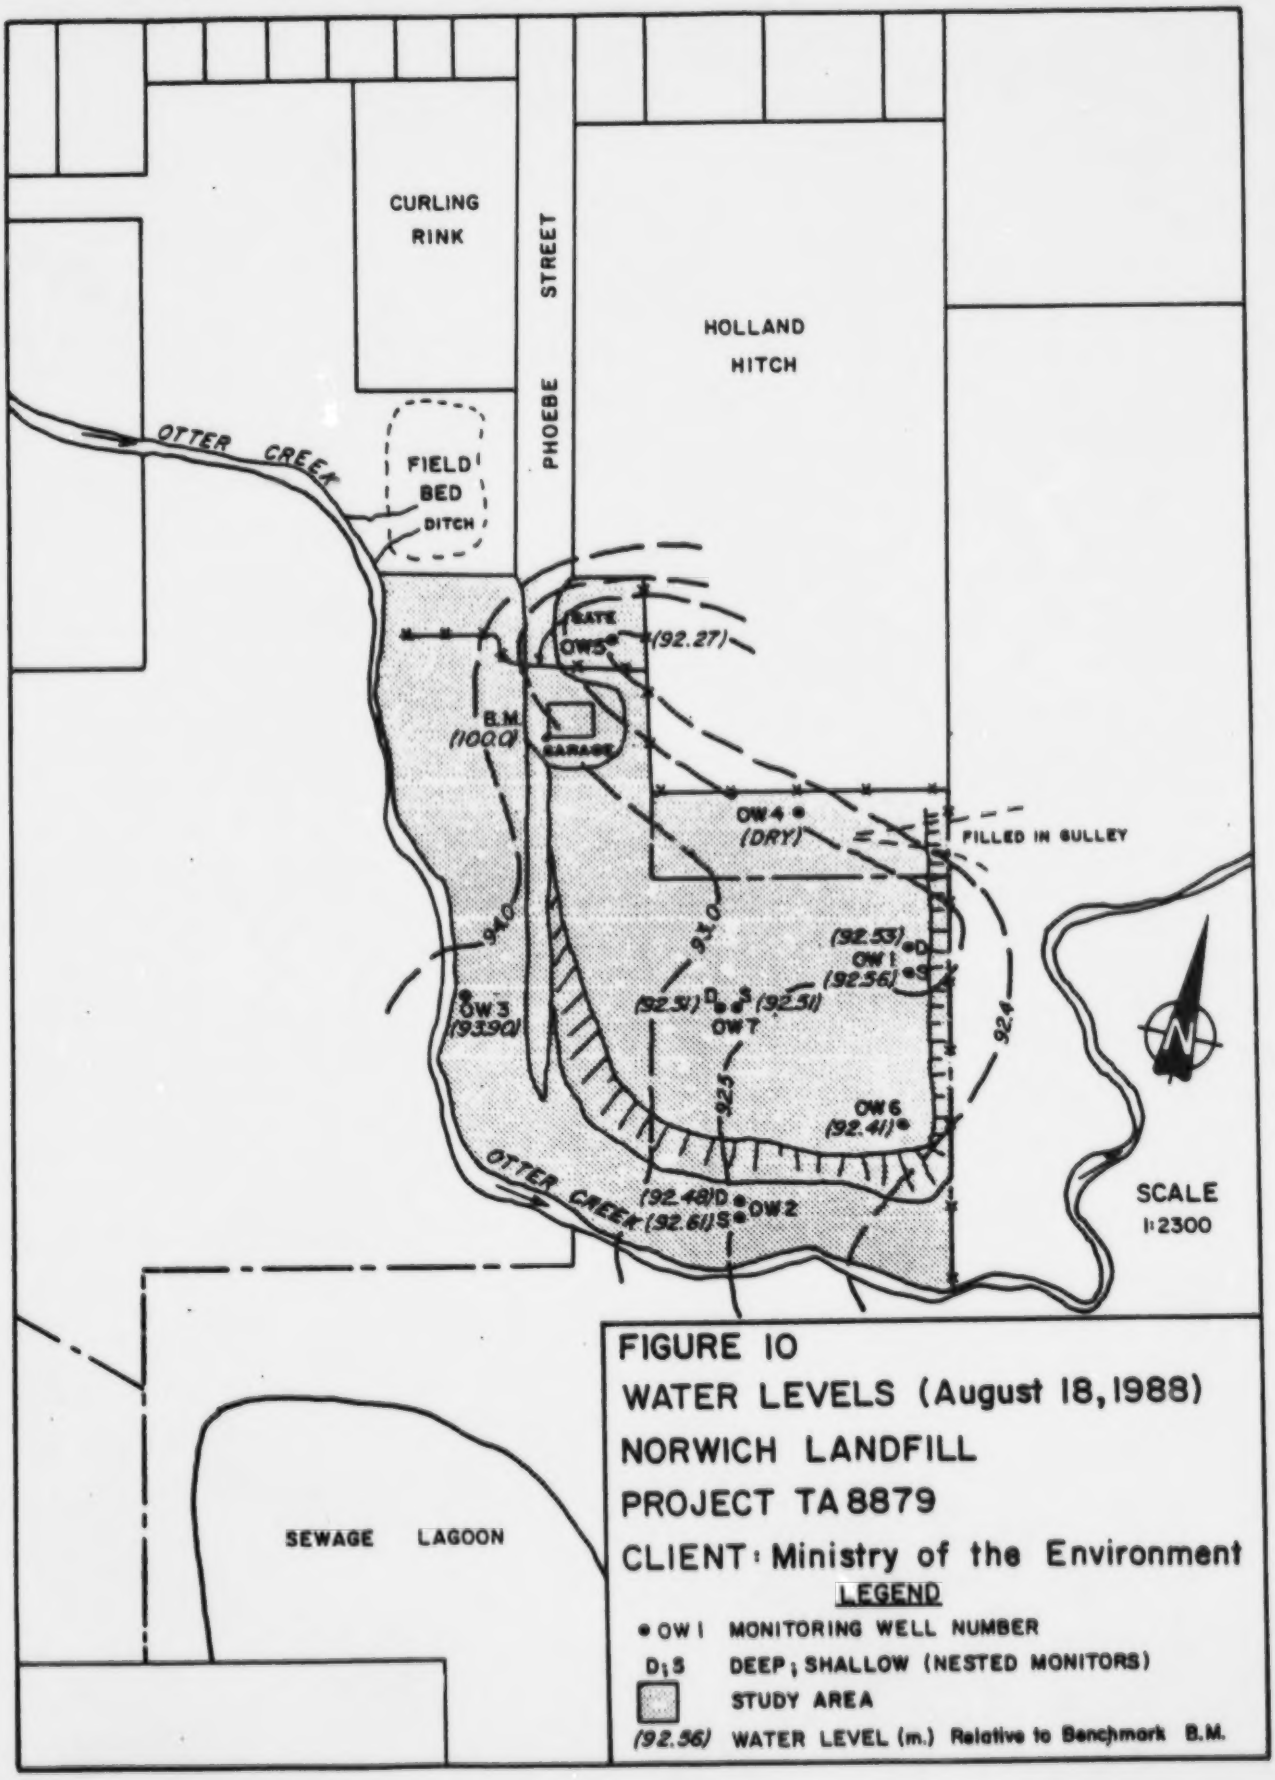
FIGURE 9
WATER LEVELS (July 27, 1988)
NORWICH LANDFILL
PROJECT TA 8879
CLIENT: Ministry of the Environment

Groundwater in the shallow overburden generally flows from the west to east across the waste disposal area (Figures 9 and 10), and appears to be controlled by the till elevation. The water table is relatively flat across of the site but is high where the till is elevated. Along the northern limit of the site, however, the flow pattern is irregular due to the presence of a relict gully which had been filled and covered.

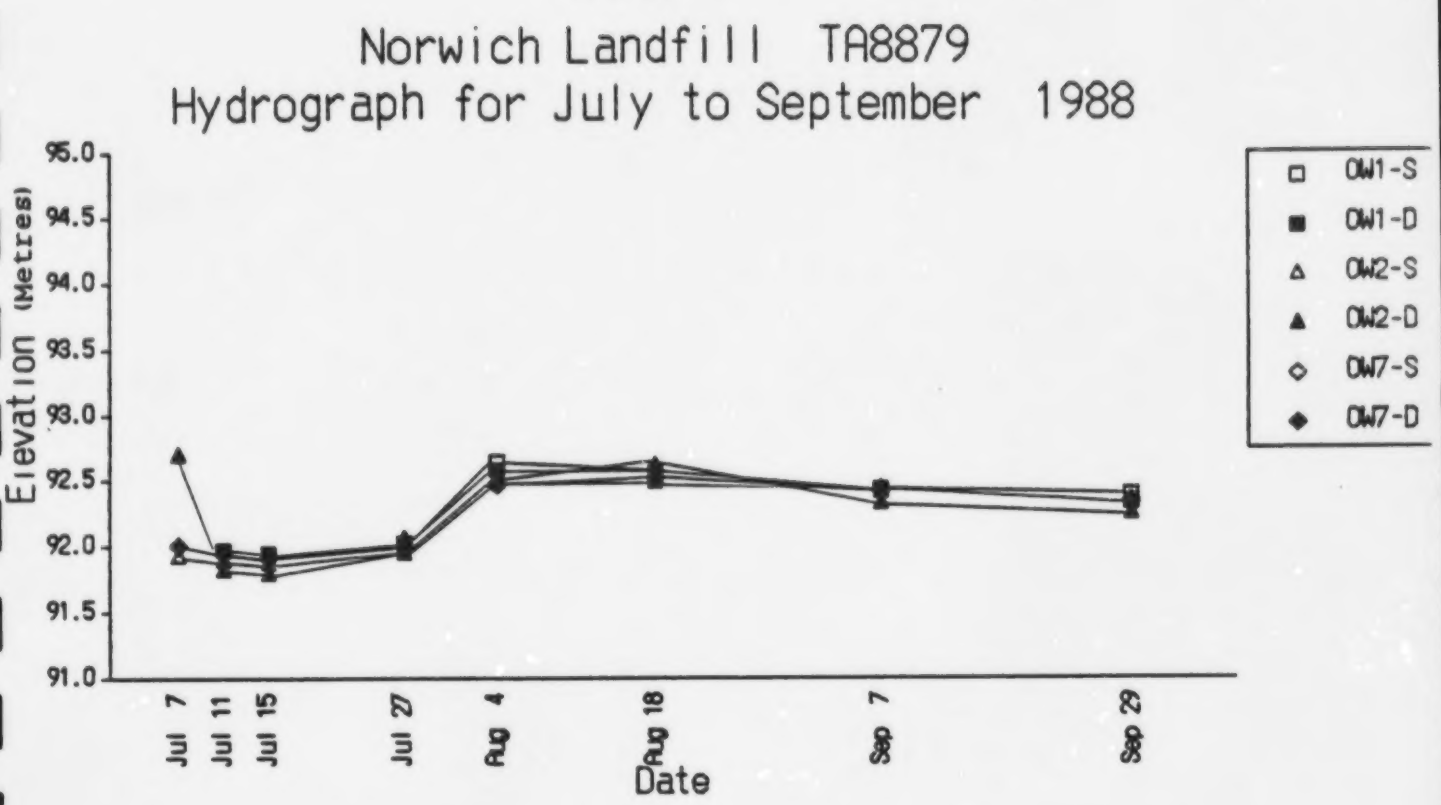
FIGURE 11.

During the 1988 mid-summer drought, the static water level was located immediately below the waste in OW7-S and OW7-D. In mid-August, however, the water level had risen to 0.5 metres above the base of the waste (Table 3, Figures 11 and 12). Given the apparent groundwater flow direction, it is expected that if any leachate plume exists it would most likely impact monitors OW2, OW7, OW1 and OW6, and that OW3 and OW5 would indicate background levels of constituent chemical parameters in the groundwater.

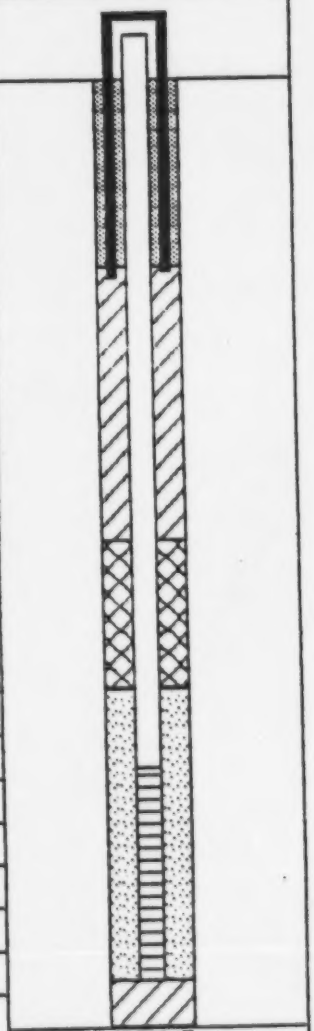
BOREHOLE NO. OW7

DEPTH metres	DESCRIPTION	SAMPLE INTERVAL	GROUND WATER MONITORS
0	FILL – asphalt, burnt wood, black fill interlayered with rust coloured silty sandy, gravelly, fill.		
1			
2	– brown/black fill, charred wood chips – compact, dense brown/ black silt		
3	LAYERED SAND and GRAVEL		
4	– rust coloured coarse sand and gravel		
5	– medium to coarse sand, black grading to orange. – medium sand, rusty bands – rusty coarse sand, gravel – very fine to medium sand interlayered with clayey silt		
6	– medium sand with silt silt, gravel, large stones.		BOREHOLE TERMINATED

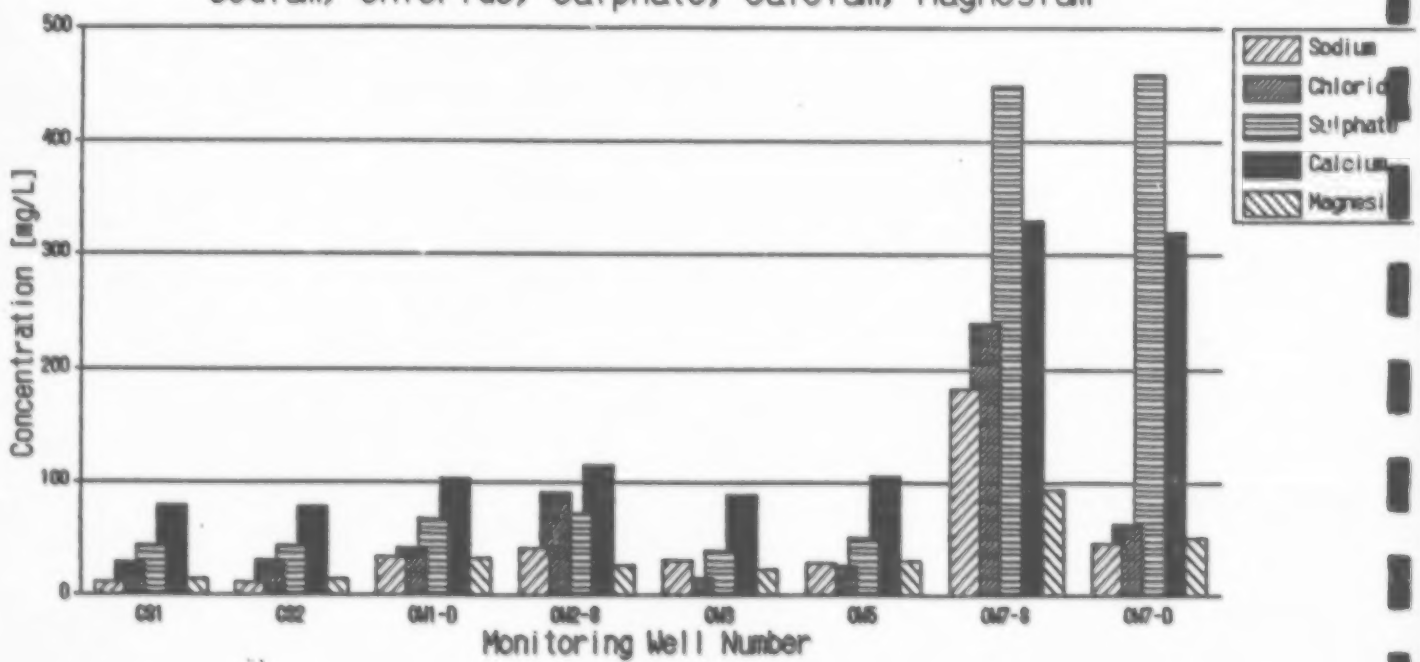
Figure C-1 Results of Water Quality Analysis
Norwich Landfill TA8879
Sodium, Chloride, Sulphate, Calcium, Magnesium

Concentrations of organic nitrogen (ranging from 0.19 to 1.66 mg/L) which exceed the maximum desirable concentration (MDC) of 0.15 mg/L, as outlined in the MOE Drinking Water Objectives, were found in all samples analysed (Figure C-1). It should be noted that the MOE Drinking Water Objectives are used as a means of comparison only: this water is not used for drinking purposes. The highest concentrations of organic nitrogen (1.66 and 1.44 mg/L) were detected in creek samples CS1 (downgradient) and CS2 (upgradient) respectively. Excess organic nitrogen may be associated with organic fouling; taste and odour problems have usually been associated with organic nitrogen levels of 0.15 to 0.2 mg/L or greater (MOE, 1983).

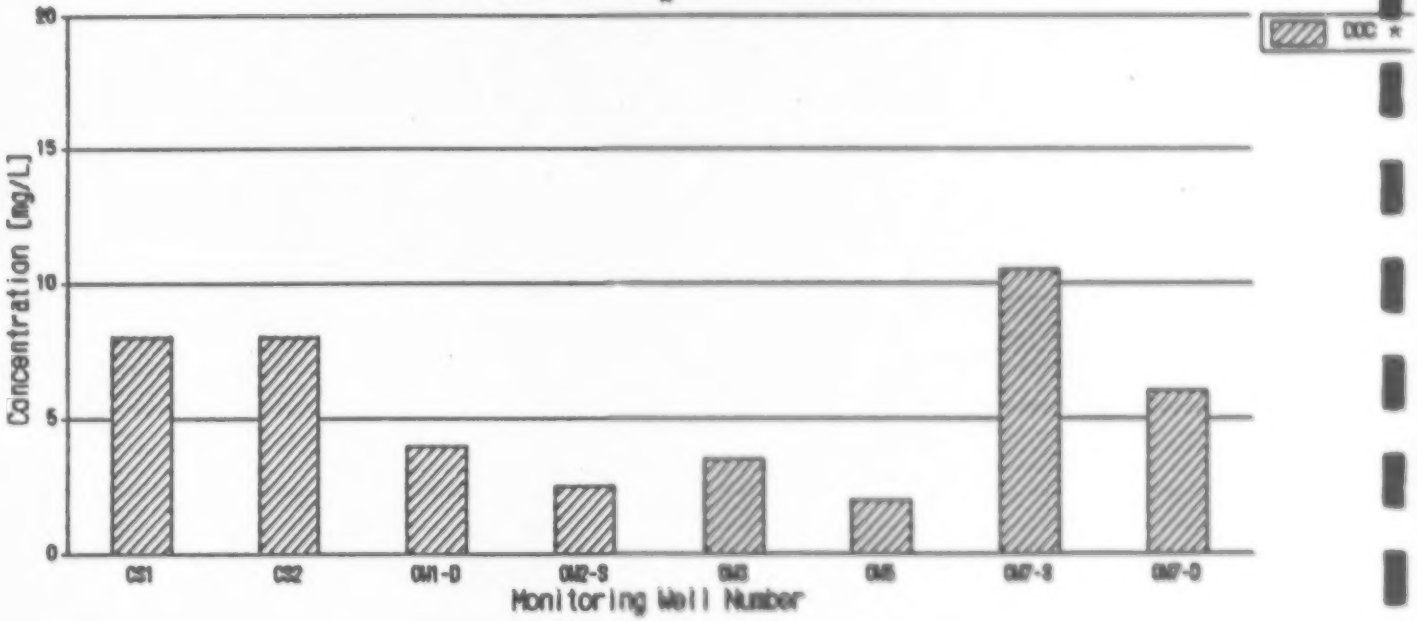
Figure C-4 Results of Water Quality Analysis
Norwich Landfill TA8879
Dissolved Organic Carbon

Concentrations of dissolved organic carbon (DOC) exceeded the MDC of 5.0 mg/L total organic carbon in CS1 (8.0 mg/L), CS2 (8.0 mg/L), OW7-S (10.5 mg/L) and OW7-D (6.0 mg/L). Water from the remaining monitors, three of which are situated between OW7 and Otter Creek, ranged from 2.0 to 4.0 mg/L (Figure C-2). High levels of organic carbon in water may result either from naturally occurring matter, such as would be found in a creek bed (CS1 and CS2), or from man-derived sources (i.e. waste); elevated
